**Building
Advice
Bureau**

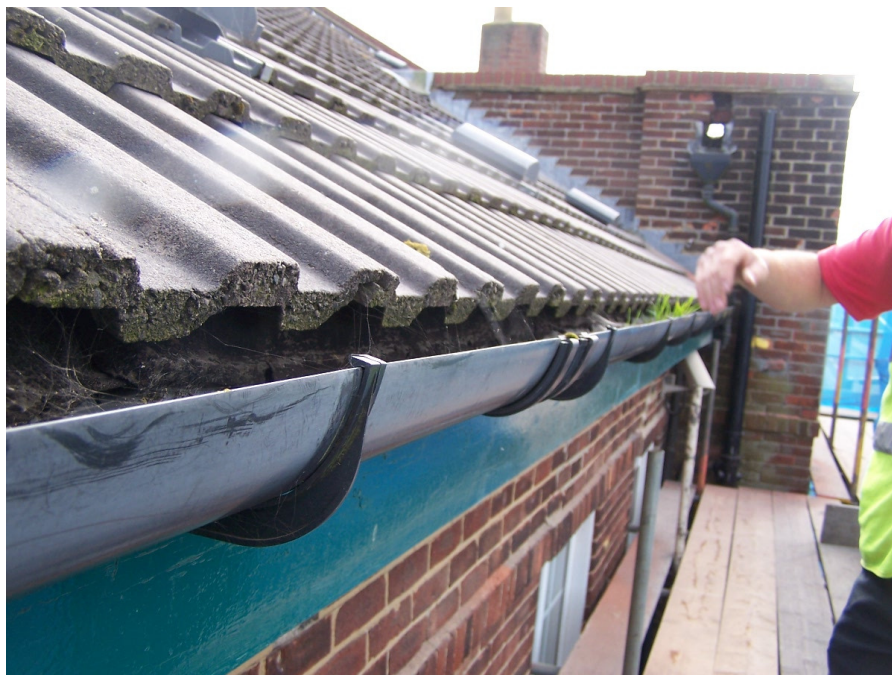
Over time the sarking felt that offers secondary protection from water situated under the tiles has been found to deteriorate and retract back behind the fascia boards.

The felt used to be mineral based and it is affected by the weather, the results are that any water That finds it way under the tiles, instead of flowing into guttering, starts to deteriorate timber to fascias

And can in turn find its way into the top corner of the room
